# **Deformation Studies of the Dam of Mornos Artificial Lake via Analysis of Geodetic Data**

**Vassilis GIKAS, Demetris PARADISSIS, Kostas RAPTAKIS and  
Olga ANTONATOU, Greece**

**Key words:** GPS, Mornos dam, structural deformation, precise leveling

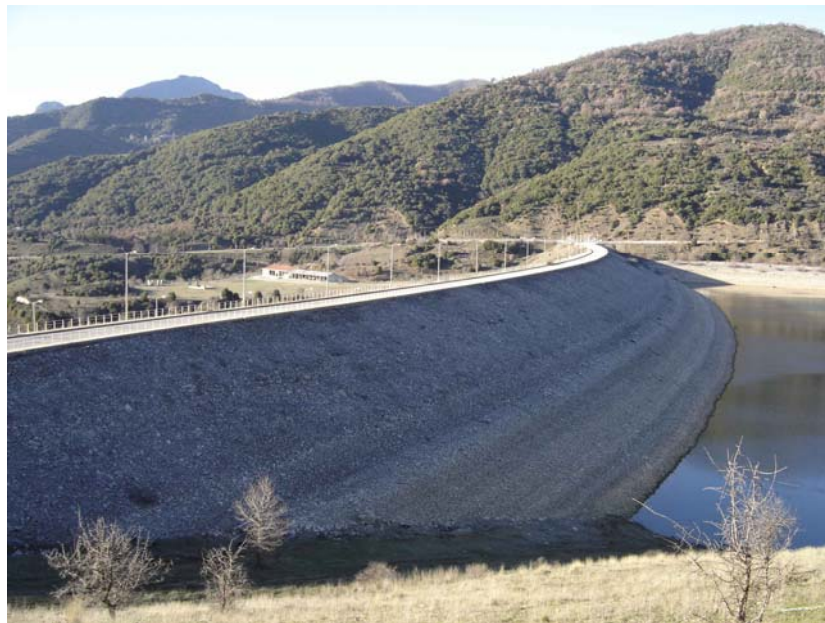
**Figure 2:** Upstream view of the Mornos dam and its surroundings.
