Integrated surveying system for landslide monitoring, Valoria Landslide (Appennines of Modena, Italy)

Eleonora BERTACCHINI, Andrea CAPITANI, Alessandro CAPRA, Cristina CASTAGNETTI, Alessandro
CORSINI, Marco DUBBINI and Francesco RONCHETTI, Italy

WWFIG09 - Eilat ,Israel,3-8 May 2009- TS3F

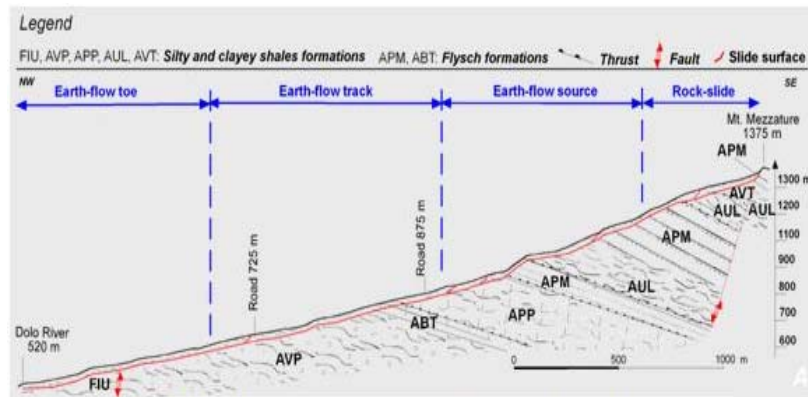
Cross section of the Valoria landslide

- In the slope, these rocks are deformed by overthrusts and faults.
- thickness between 5 and 40 m

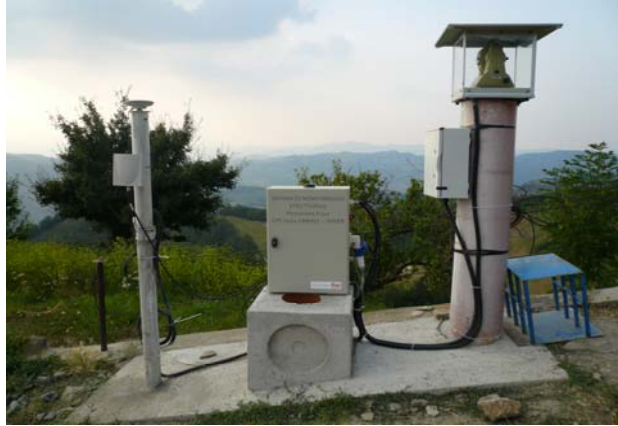
- robotic station (*TCA2003 Leica*) and of a double frequency GPS receiver (*GMX902 Leica*) with an antenna *AX1202 Leica*.
- bi-dimensional clinometer (*Nivel 220 Leica*)
- remote control at university and Authority for hydrological risk monitoring.

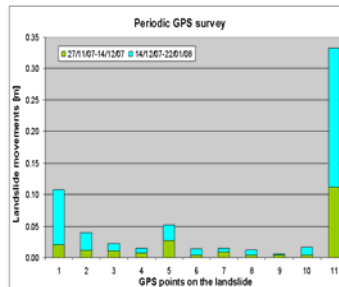
Landslide movements: $ \Delta $ in [m]		
GPS point ID	27/11/2007-14/12/2007	14/12/2007-22/01/2008
1	0.0200	0.0873
2	0.0106	0.0284
3	0.0100	0.0117
4	0.0076	0.0071
5	0.0270	0.0241
6	0.0041	0.0095
7	0.0095	0.0054
8	0.0036	0.0082
9	0.0036	0.0020
10	0.0040	0.0122
11	0.1123	0.2206

Landslide displacements detected with GPS periodic surveys

Most **significant displacements**, measured by periodic surveys, took place during **autumn 2007** : from **few cm to meter per day** at the toe.

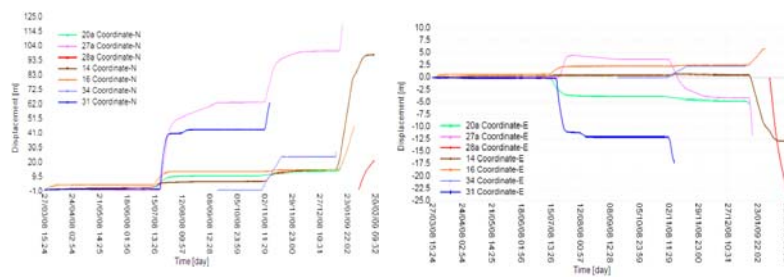
• Landslide movements by automatic TS during continuous measurements. Monitoring of coordinates N (left), E (right) of the most interesting reflectors.

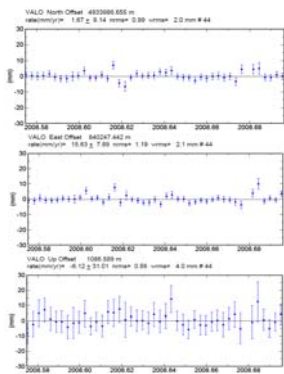
Tilt of robotic station (up) and measurements of bi-dimensional clinometer (bottom)

The cyclic movement of master station seems to be perfectly elastic, so it should not disturb data analysis and results interpretation

The **stability of station pilaster** used for Robotic instrument was controlled.

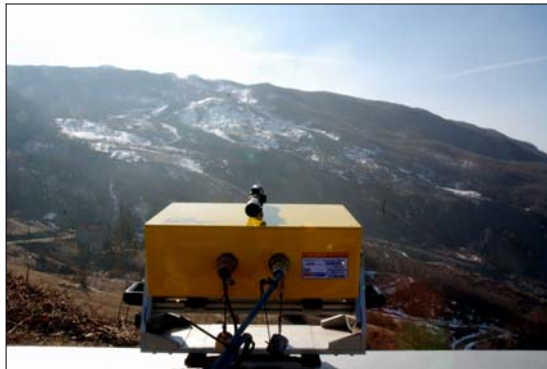
landslide upper part

DISTANZA DAL VERSANTE	[m]	450-1300
APERTURA ORIZZONTALE ANTENNE	[grad]	38
RISOLUZIONE IN RANGE	[m]	0.5
RISOLUZIONE IN CROSS-RANGE	[mrad]	4.5
ACQUISIZIONI PER ORA	-	9
DURATA SESSIONE	[ore]	24

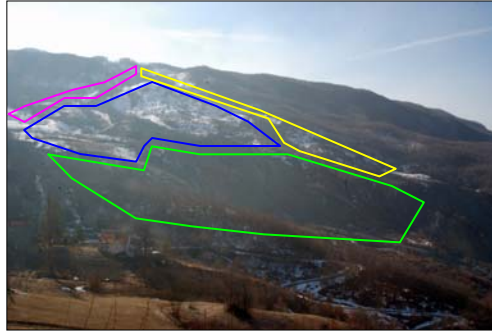
Sezione 1	Blue
Sezione 2	Magenta
Sezione 3	Green
Sezione 4	Yellow

Geocoded Quality Map

Dalla mappa di qualità si evidenziano circa 40000 buoni punti di misura

about 40 000 points are good Internal parameter >0.7 due to electromagnetic response

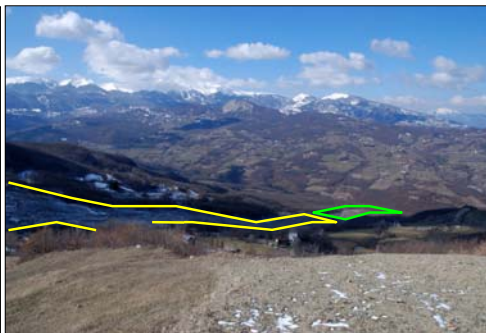
Sezione 1	
Sezione 2

Geocoded Quality Map

Dalla mappa di qualità si evidenziano circa 40000 buoni punti di misura

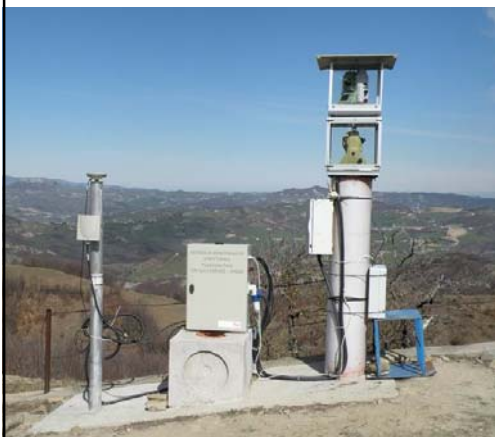
New TM30 Leica Automatic Station

Test in progress
- interferometric survey (IBIS system)
-New Automatic total station Leica TM30

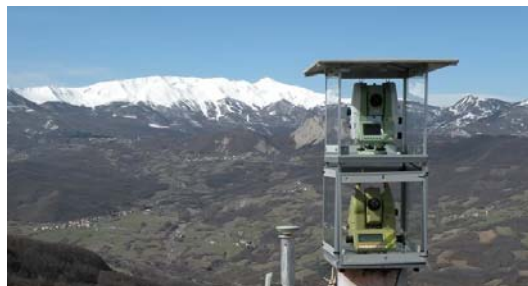
very long range EDM

Leica TM30 - accurate and very quick (three times rather than Leica TCA2003)
