Detecting Fire Damaged Concrete Using Laser Scanning

**Craig Matthew HANCOCK, UK, Gethin Wyn ROBERTS, China, Luke BISBY, UK,
Martin CULLEN, UK, James ARBUCKLE, UK**

Key words: Laser Scanning, Concrete, Deformation Monitoring, Fire

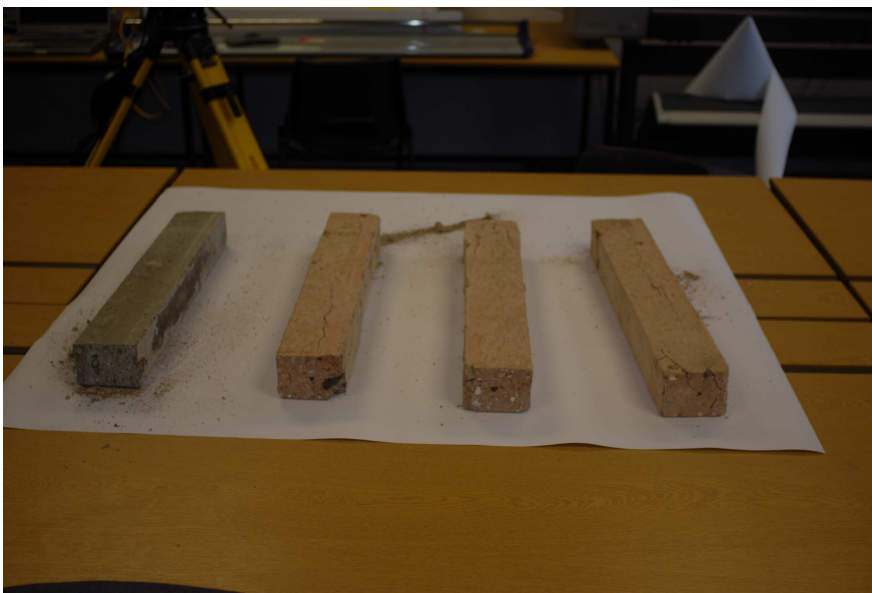
Figure 3 shows four identical pieces of concrete. Three of these blocks have been heated gradually from a temperature of 200°C to a temperature of 990°C in a kiln for a period of three days. This meant that the heating of this concrete was very controlled. The block on the far left of Figure 3 has not been heated at all but has been kept at normal room temperature.

Figure 3: Four concrete samples, the three to the right have been heated to 990°C, the one on the far left has been kept at room temperature

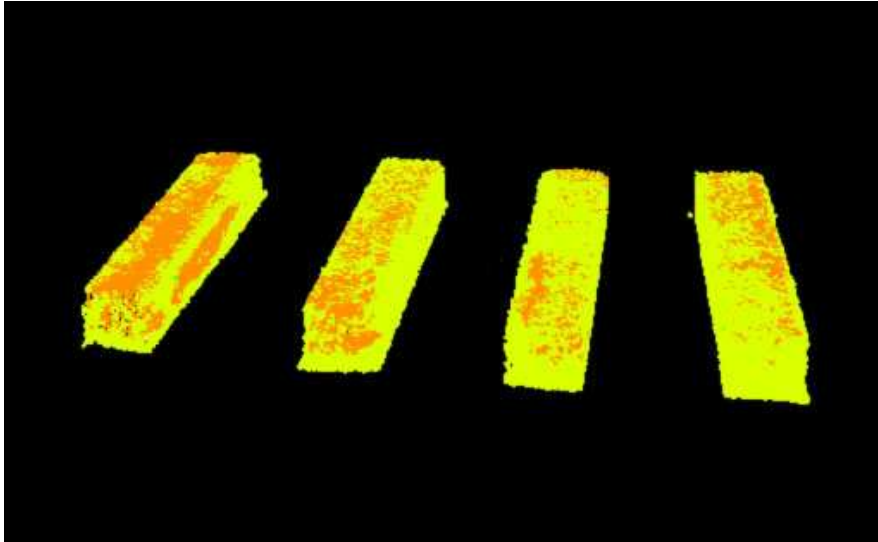
The concrete blocks were then scanned using a Leica HDS3000 pulse laser scanning. The intensity value of the returned signal is shown below (Figure 4). Using the HDS3000 on its highest setting, approximately 90,000 points were collected. From Figure 4 there is a visible difference between the concrete that has not been heated (far left) and the heated concrete as the non heated concrete is more orange in colour compared with the yellow of the heated concrete. This difference however is not obvious.

Figure 4: HDS3000 intensity return values for the four concrete samples
