# Rebuilding Christchurch in the Wake of the 2010 & 2011 Earthquakes - A Surveyor's Perspective

Simon Ironside  
Eliot Sinclair & Partners Ltd.  
Christchurch, New Zealand

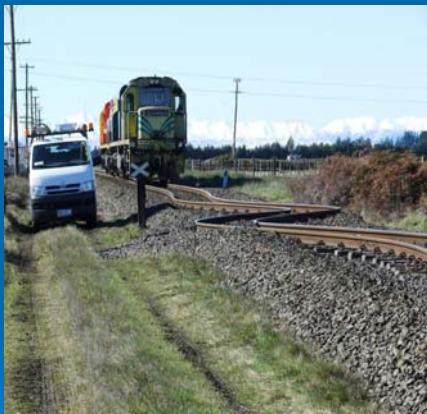
- Previously unknown Greendale Fault ruptured through to the ground surface, producing a 30km long surface rupture.

Near Rolleston on the Main Trunk Line - Courtesy of Malcolm Teasdale of KiwiRail

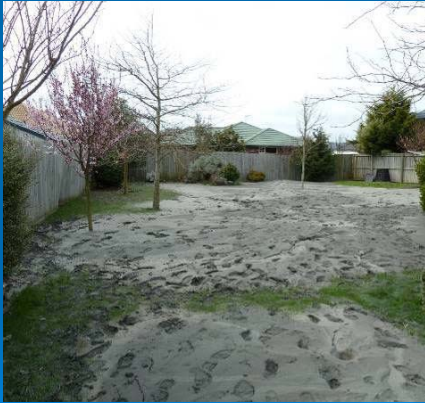
## 4 September 2010 Earthquake Liquefaction

- Liquefaction occurs when saturated, unconsolidated soils are severely shaken causing water and silt or sand to be ejected to the ground surface.
- Predominant in the riverside suburbs of Avonside, Dallington, Burwood, Avondale, Halswell and in Kaiapoi.

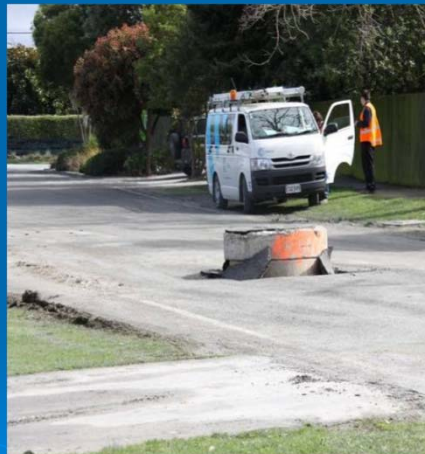
## 4 September 2010 Earthquake Liquefaction

- Also the river delta areas of Bexley, Brooklands, Spencerville, Pines Beach, and Kairaki.
- Ground settlement and lateral spreading caused by liquefaction resulted in considerable land and building damage, including underground services.

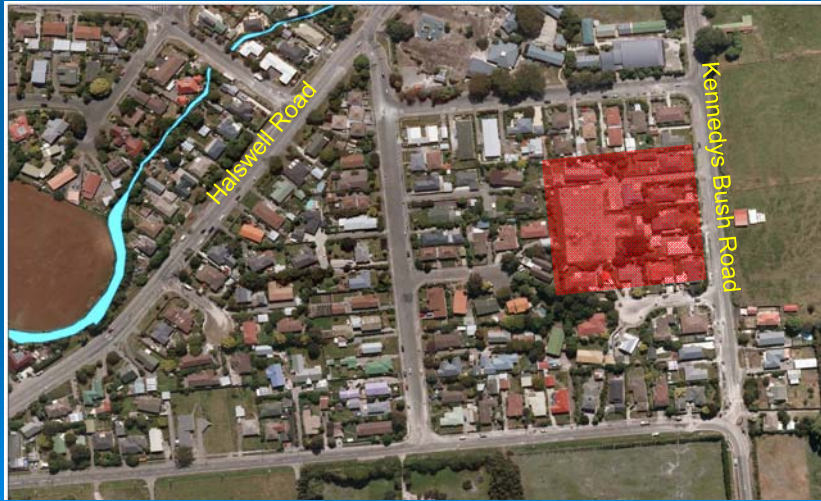
# Category 5 Boundaries

- Christchurch earthquake did not fall neatly into a fault rupture scenario – proximity of the epicentre and shallowness of the event.
- The cadastral fabric had been affected roughly in line with damage to land and property
- Post 22 February Category 5 boundaries in particular were becoming difficult to re-define.
- In some situations surveyors were finding distortion, compression, rotation, lateral spread/liquefaction all within the area under survey.
- Ongoing discussions with local LINZ staff to find solutions

- Some clarity around Category 5 boundaries.
- LINZ now accepts that groups of local marks that have retained the same relationship relative to one another may be used for parcel definition.
- Marks found that appear to be undisturbed but do not agree with the marks used for the boundary definition can now be recorded in Landonline (UNPROVEN).
- Landonline now able to accommodate the distortions found on the ground.
- Boundary definition is a matter of a surveyor's judgement, skill and experience substantiated by evidence of the survey/boundary marks found.
